RETENSIONING OF SOLARGLIDE SUNSCREENS

On occasions **SOLARGLIDE** sunscreens can become detensioned. Following these simple instructions can retension them again quickly and easily.

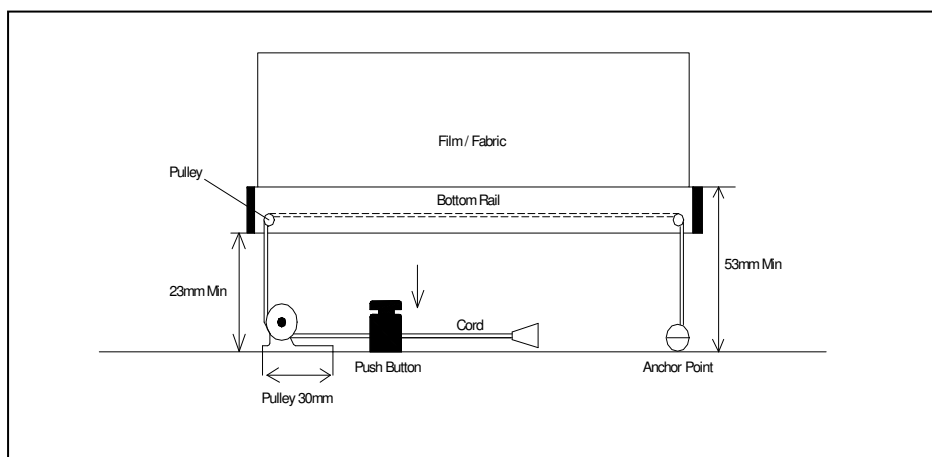
4. Whilst applying downward pressure on the end cap to keep it flush to the cassette, slowly rotate the end cap clockwise until resistance is felt. This resistance means that the blind spring is beginning to retension. Once you start to feel the resistance take a further three turns.
5. Replace the three screws into place whilst continuing to apply downward pressure on the end cap, please note that if you let go at this point the blind will spring back to the position you started at and you will have to start the whole procedure again.
6. When the screws are tightened the blind should then be fully retensioned and ready for operation (see figure 1 below)

1. Place the cassette vertically onto a flat surface, with the right hand side of the blind cassette facing downwards (the right hand side black cassette end cap should be flat to the surface)
2. The opposite end of the cassette profile (left hand side) should now be visible facing upwards
3. Carefully remove all three fixing screws with a cross point screwdriver whilst tightly holding the black (cassette) end cap in place. It may be best to ask for assistance from another person at this stage.

CAUTION – if the end cap is removed or not held securely in place then the blind will fully detension.

To replace damaged end caps firstly replace the right hand end cap – then follow the above procedures for replacing the left hand side end cap and retensioning of screens
